SUMMARY REPORT
GROUND PROJECT SURVEYS
FOR THE QUARTER ENDED
MARCH 31, 2006

SIGIR PA-06-052
JULY 31, 2006

SUBJECT: Summary Report Ground Projects Surveys for the Quarter Ended
March 21, 2006 (Report Number SIGIR-PA-06-052)

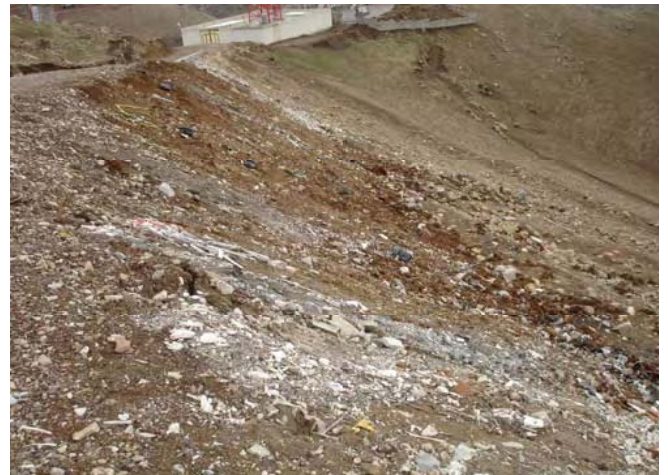
- Spot welds on the generator roofing appeared to be of poor quality.
- The facility is located approximately 20 feet up gradient from a steep slope. Retaining walls were not installed to stabilize the slope and signs of lateral movement were observed. Site Photo 6 shows the steep slope.

Site Photo 6: Down gradient slope with signs of lateral movement (Project 12807)

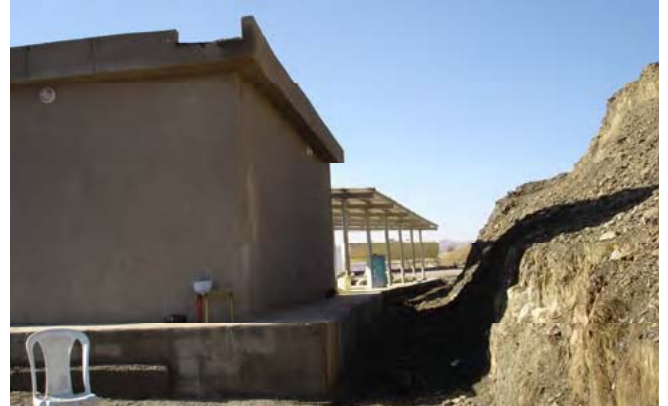
- The area behind the jail facility is a cut bank without a retaining wall, making it susceptible to erosion. Site Photo 12 shows the cut bank behind the jail facility.
- Numerous areas of poor finishing of exterior walls, interior walls, and roof tiles were reported.

Site Photo 12: Cut bank behind jail facility (Project 12827)

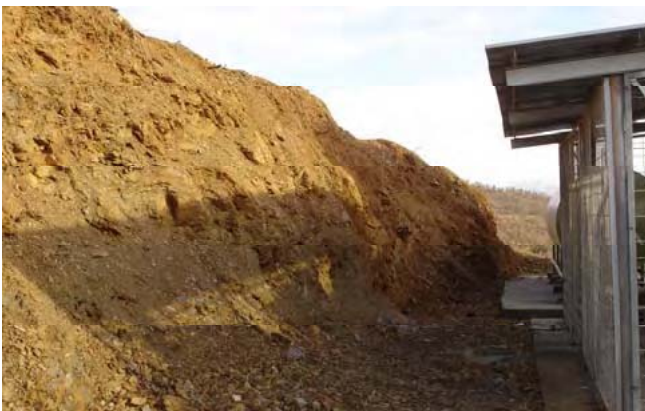
- No perimeter security fences or gates were present.
- The road to the border post was reported as difficult to access during the rainy or snowy seasons.
- The area behind the generator is a cut bank without a retaining wall. Site Photo 17 shows the cut bank behind the jail facility.
- Potable water was brought up to the border post from a nearby spring using plastic containers. No filtration or sterilization (except boiling) of the water was available.
- Spot welds on the generator roofing appeared to be of poor quality.
- Surface of exterior walls was not straight (inward curvature) and poor finishing was observed. Cracks were observed on the exterior wall below the parapets. Site Photo 18 shows the cracks in the exterior wall below the parapets.

Site Photo 17: Cut bank behind generator without retaining wall (Project 12835)

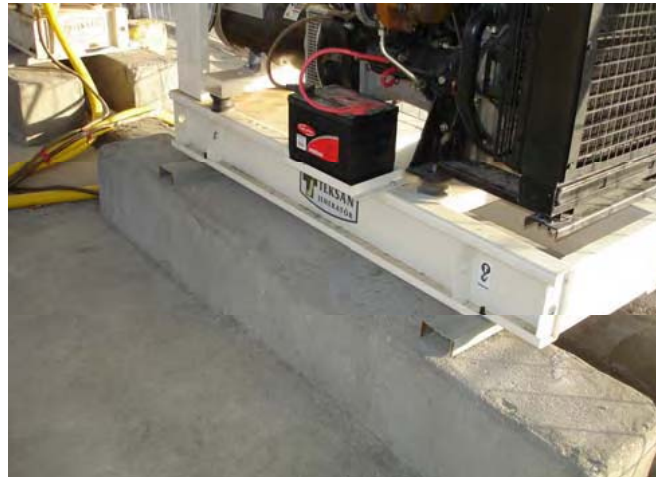
Site Photo 21: Generator on concrete base (Project 12850)

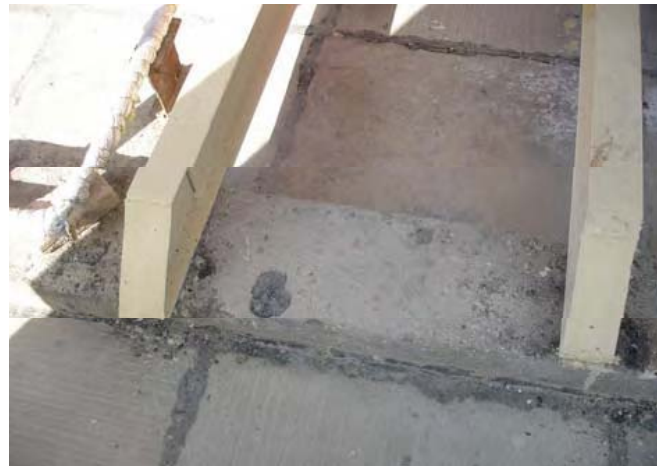
- No perimeter security fences or gates were present.
- The generator was not anchored to the concrete base. Site Photo 22 shows the generator and concrete base.
- Spot welds on the generator roofing appeared to be of poor quality.
- Poor finishing and broken concrete was observed at the septic tank cover.
- Roof water tanks base girders were not fastened to the concrete foundation. Site Photo 23 shows the water tank base.

Site Photo 23: Roof mounted water tank base (Project 12855)

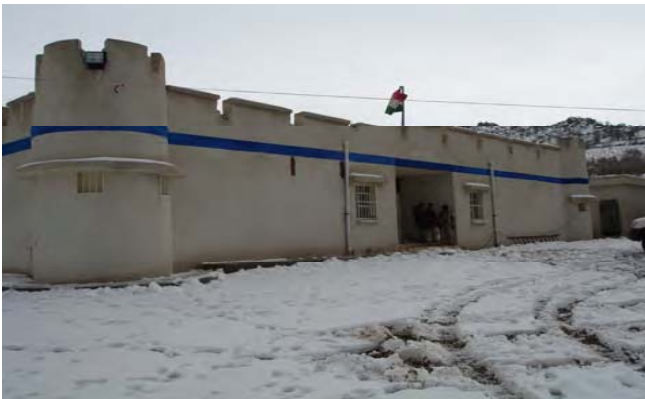
- No perimeter security fences or gates were present. Site Photo 24 shows the exterior of the border fort.
- The generator was not anchored to the concrete base.

Site Photo 24: Front exterior of border post (Project 12884)

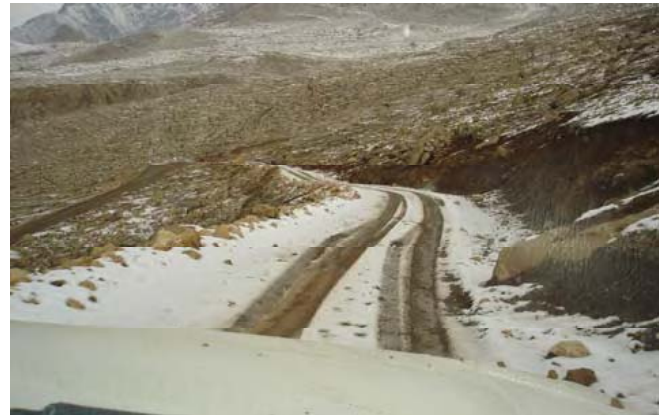
- Spot welds on the generator roofing appeared to be of poor quality.
- Structural steel retrofit required due to the deflection of I-beams was in-progress.
- The road to border post was reported as difficult to access during the rainy or snowy seasons. Site Photo 25 shows the access road.
- Potable water was reported trucked in for use and users reported that they are concerned about the quality and quantity of the water. No filtration or sterilization (except boiling) of the water was available.

Site Photo 25: Access road (Project 12884)

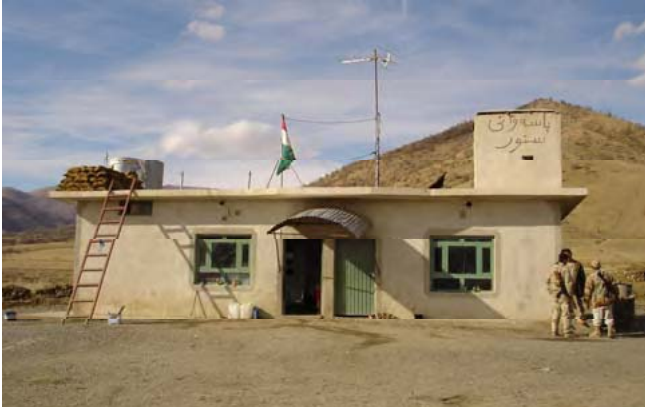
- Site Photo 30 shows an exterior view of the front of the border post.
- Electricity is supplied by a 12 KVA generator.
- The water well was reported to have dried up, and a small creek, with “dirt and worms” was the only current source of water.
- Road access to the site was reported to be difficult.
- The septic tank was reported almost full, with no plans for cleaning.
- The interior ceiling showed signs of water damage and ceiling plaster was deteriorating (Site Photo 31).
- The facility lacked security fences.
- The facility showed a lack of any recent maintenance or remodeling.

Site Photo 30: Front exterior of border post (Project 20571)

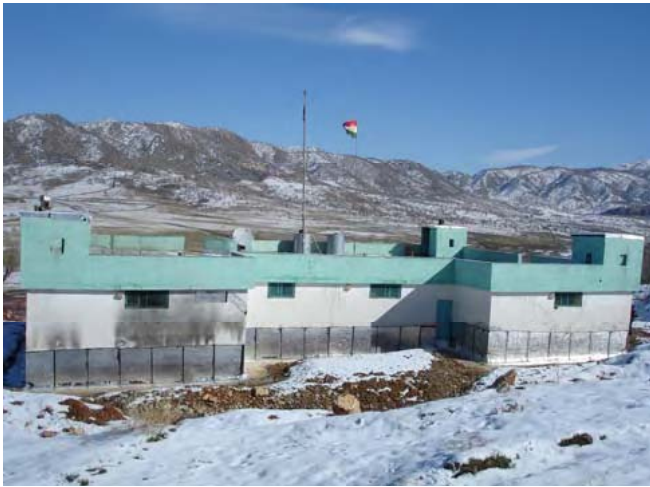
- Site Photo 34 shows the exterior to the border post.

Site Photo 34: Exterior view of border post (Project 20573)

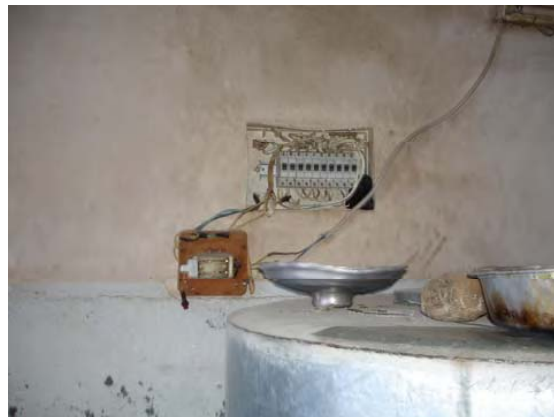
- Electricity is supplied by a 15 KVA generator.
- Two septic systems were observed on site. One of the tanks was reported to have collapsed shortly after delivery to the site and the other one was full. The full septic tank is overflowing sewage close to the building. Site Photo 37 shows the location of overflowed sewage (border post in top right corner of photo).
- Cracks in the concrete were observed extensively throughout the exterior of the buildings and sidewalks, possibly due to differential settling of the foundation and/or poor construction.
- Security fences were not present.
- The electrical system and wiring had numerous exposed wires and uncovered panels. Site Photo 38 shows an electrical panel in the kitchen area.
- The facility showed a lack of any recent maintenance or remodeling.

Site Photo 38: Electrical panel (Project 20575)

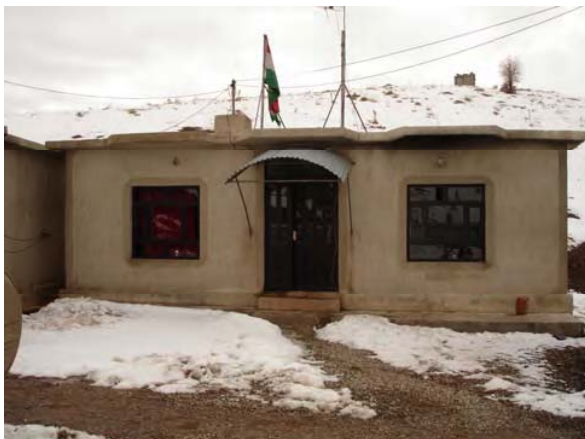
- Site Photo 39 shows the exterior front of the border post.
- Electricity is supplied by a 12 KVA generator. The generator was reportedly broken and was not on site. The border post did not have electricity at the time of the visit.

Site Photo 39: Exterior front of border post

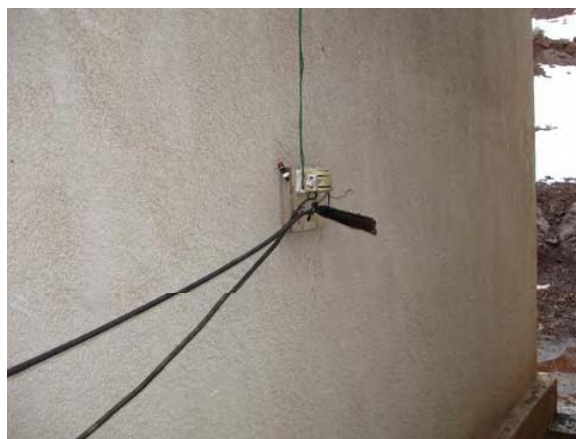
- The electrical system had exposed wires. Site Photo 40 shows an example of exterior wiring.
- The ceilings showed staining, an indication of roof leaks.

Site Photo 40: Exterior electrical wiring

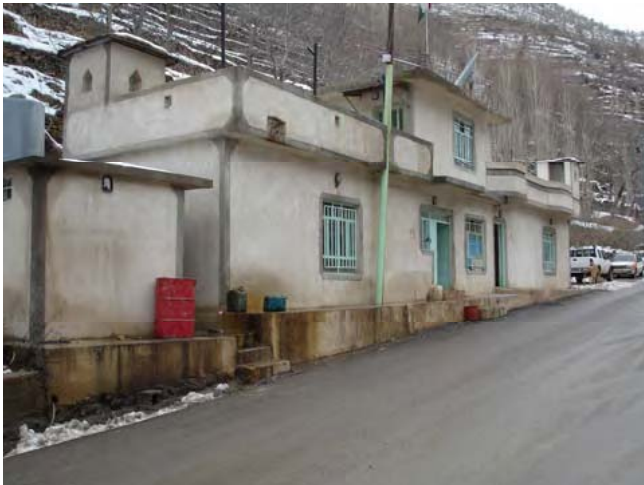
- Site Photo 41 shows the exterior of the border post.
- A 12 KVA generator was on-site, although reportedly broken. Electricity was obtained from a village generator located nearby.
- Source of water is a water spring close to the site. The spring is uncovered and water is transferred to the site through plastic water pipes. No filtration or sterilization existed and the water quantity was not enough for the requirements of the border post.
- Numerous cracks were observed in the exterior walls.
- The electrical system had exposed wires and uncovered panels. Site Photo 42 shows an example of the electrical wiring.
- Security fences were not present.

Site Photo 41: Exterior front of border post (Project 20577)

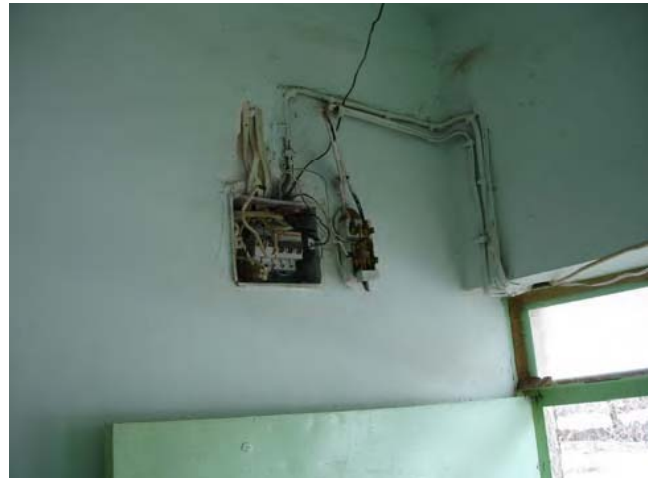
Site Photo 42: Interior electrical panel (Project 20577)

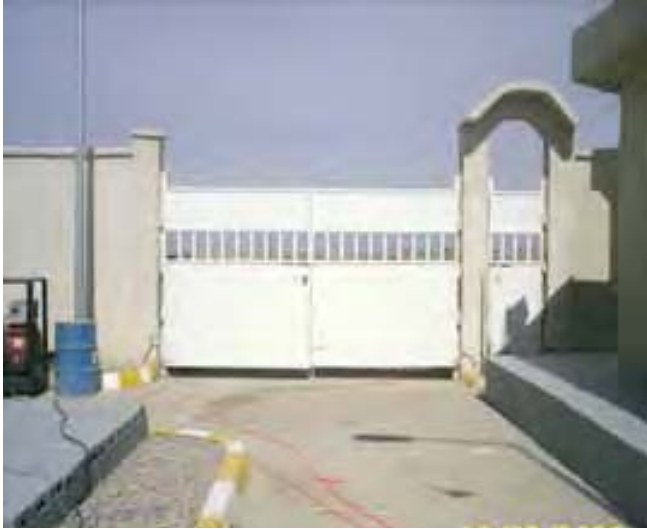
- The site visit verified new construction of the main building, sidewalks, perimeter security and guardhouse, entrance gate, and the generator shed. Site Photo 43 shows the front entrance gate.
- Two exterior located transformers (assumed 33 kilovolt (kV) / 11 kV) were observed mounted on concrete pads. A firewall was located between the transformers. Site Photo 44 shows the main transformers.
- Switchgears (assumed incoming and outgoing) were observed inside the main building. Site Photo 45 shows the switchgears.
- Thirteen split air conditioning condensing units were mounted on the roof of the main building. Site Photo 46 shows the roof mounted air conditioning condensing units.
- Exterior light poles were located throughout the facility.
- No discrepancies were reported at this location.

Site Photo 43: Front entrance gate (Project 1861)

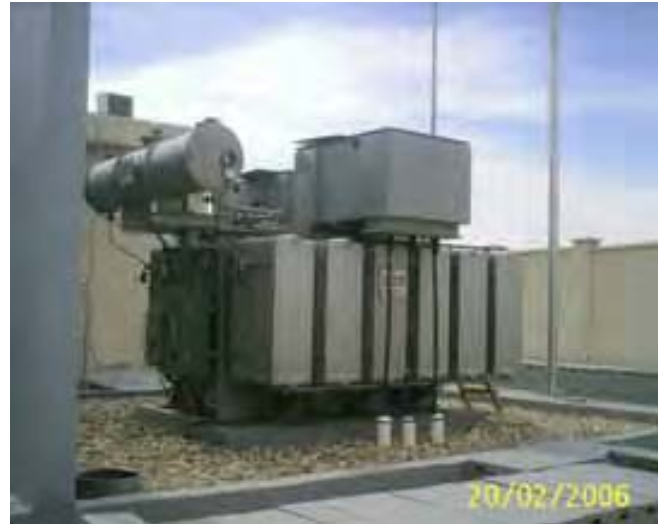
Site Photo 44: Transformer (Project 1861)

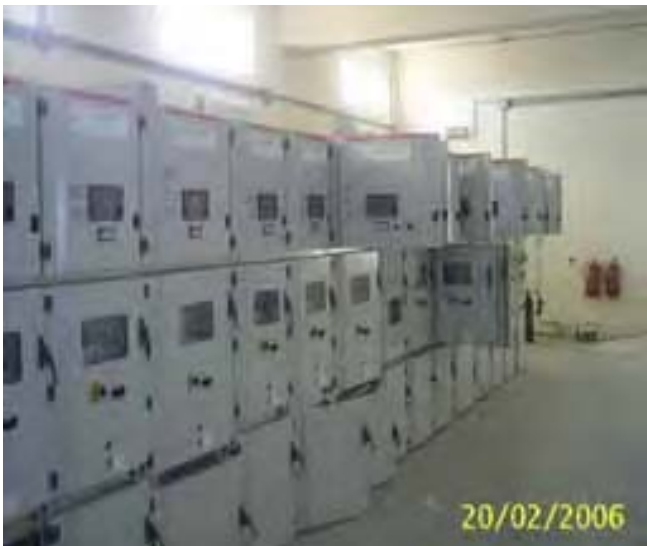
Site Photo 45: Switchgears (Project 1861)

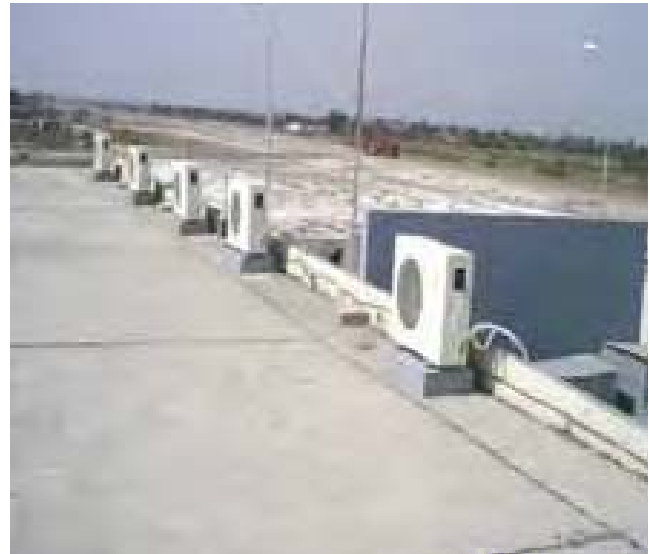
Site Photo 46: Roof mounted AC Units (Project 1861)

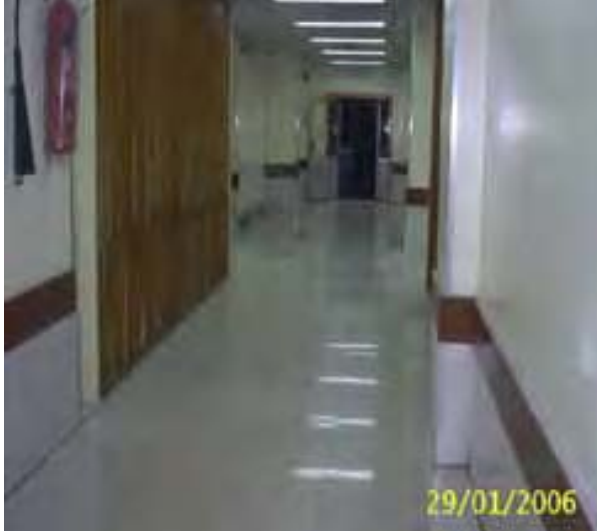
- No significant discrepancies were noted during the visit. Site Photo 47 shows an area of tile replacement, Site Photo 48 shows replaced ceiling tiles, Site Photo 49 shows renovated counter tops, and Site Photo 50 shows new electrical lighting.

**Site Photo 47: Renovated hallway floor tiles
(Project 10309)**

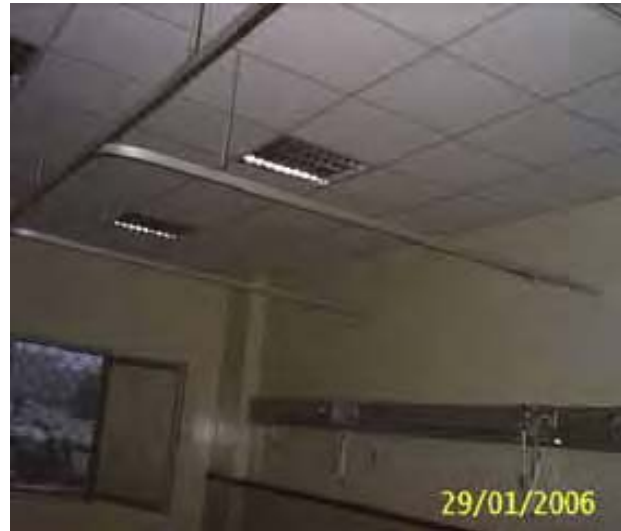
Site Photo 48: Suspended ceiling (Project 10309)

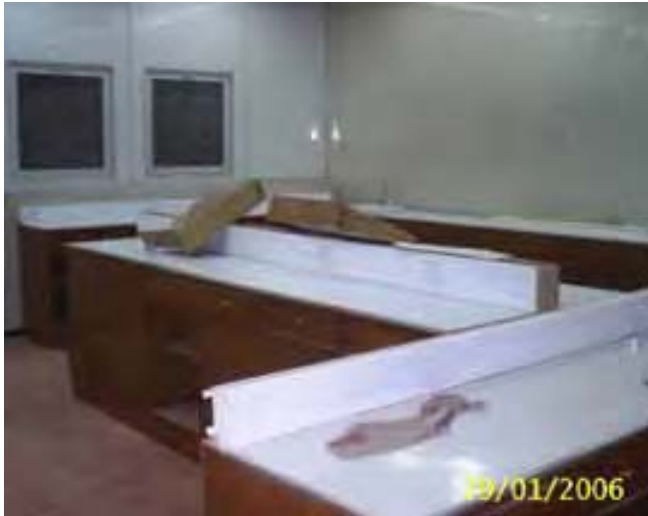
Site Photo 49: Renovated counter tops (Project 10309)

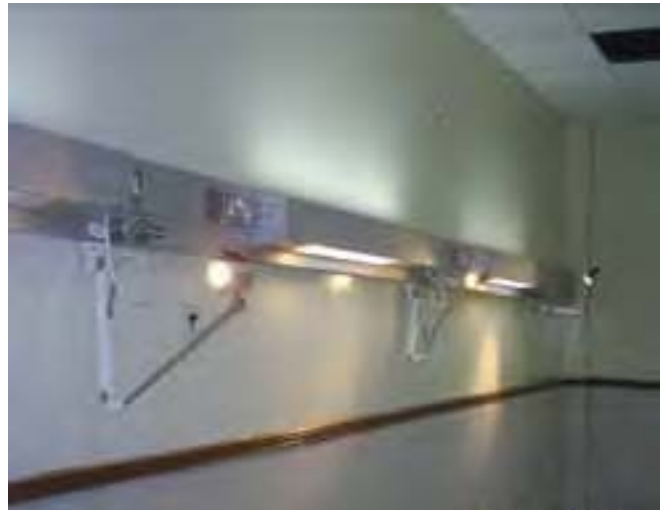
Site Photo 50: Lighting system (Project 10309)

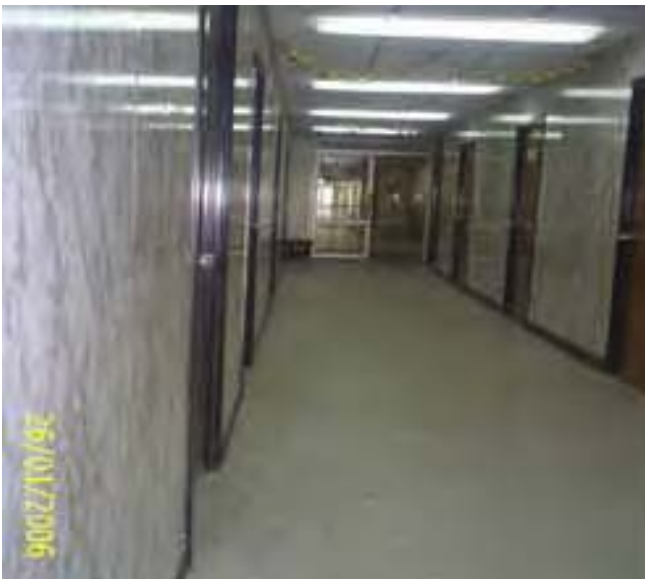
- The quality of this project was reported better than the previous contractor’s work.
- No significant discrepancies where noted. Site Photo 54 shows renovated hallway lighting repairs and Site Photo 55 shows repair of the sidewalks at the time of the site visit.

Site Photo 54: Lighting system (Project 19873)

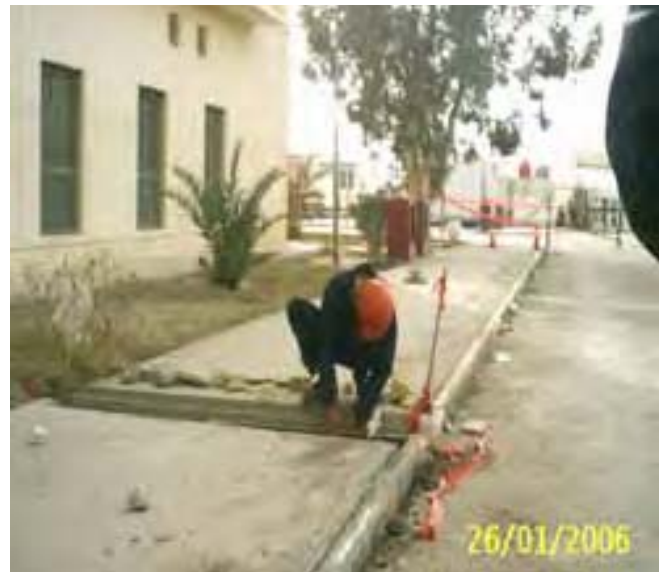
Site Photo 55: Sidewalk repairs (Project 19873)

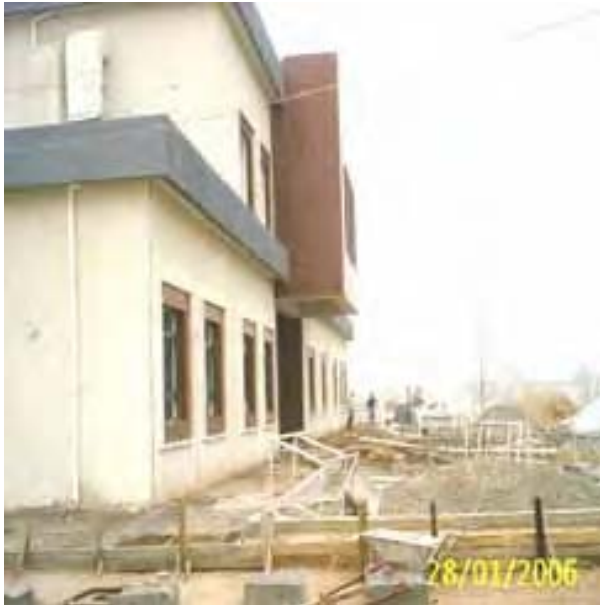
New construction was in progress at the time of the site visit and 87 construction workers were reported on site. The building was constructed with the majority of the windows, electrical, heating and air conditioning units, and septic systems in place. Remaining work included mostly finishing including completing the electrical, installation of doors and windows, installation of walkways, and painting. No significant discrepancies were noted during the site visit. Site Photo 56 shows the front exterior of the clinic and Site Photo 57 shows electrical control panels. Site Photo 58 and 59 show interior finishing underway.

Site Photo 56: Exterior of Clinic (Project 11913)

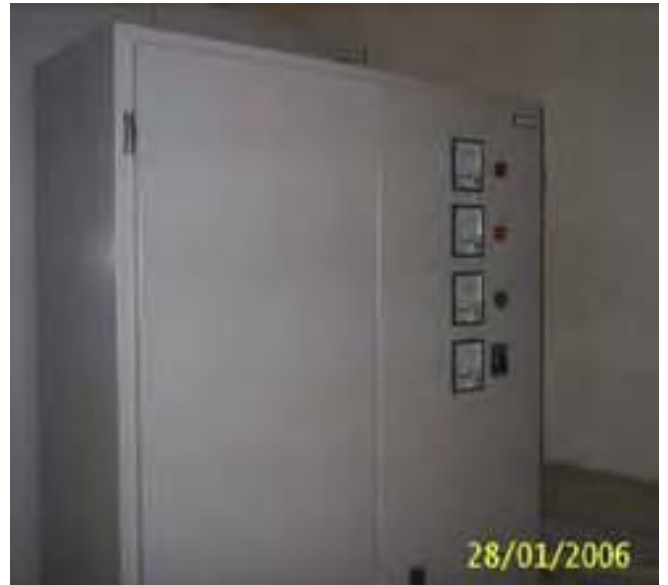
Site Photo 57: Electrical controls (Project 11913)

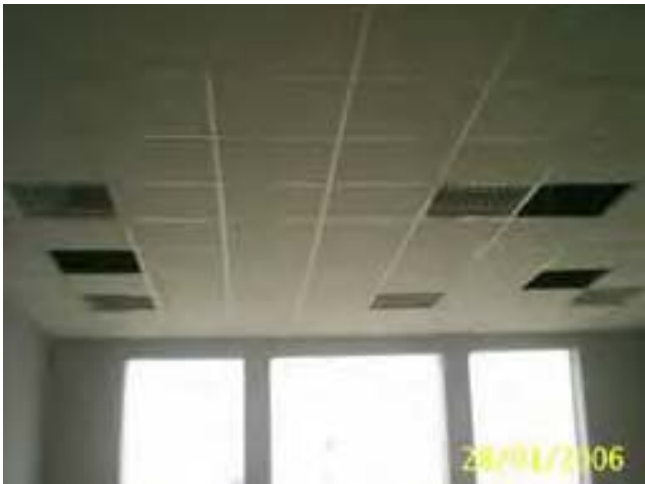
Site Photo 58: Suspended ceilings (Project 11913)

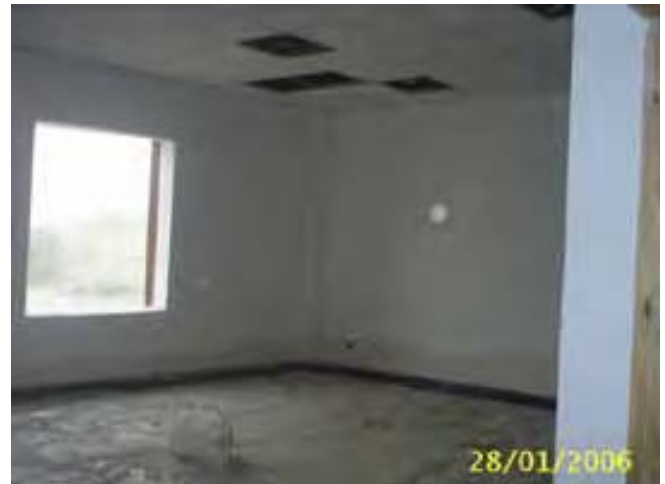
Site Photo 59: Interior room (Project 11913)

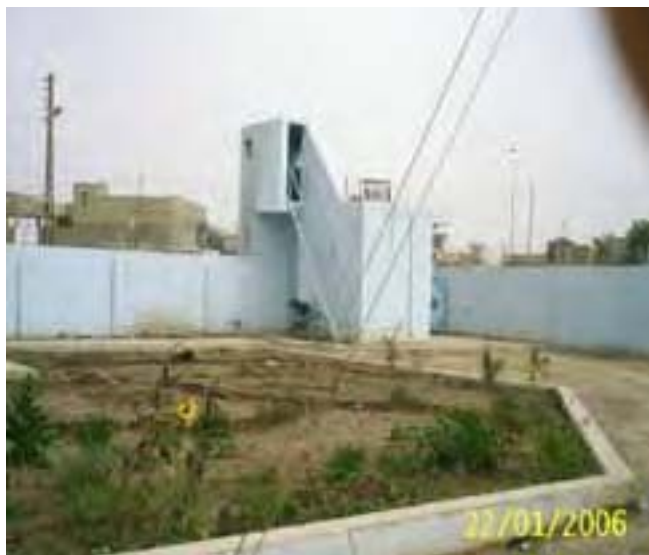
The IRMS database listed the project as 100 percent complete on 27 July 2005. The project included new construction of four guard towers, a parking lot, and an officer's room and renovation work. Site Photo 60 shows one of the corner guard posts. A new 63 KVA generator with two fuel tanks was on site. Discrepancies noted during the site visit included electrical and plumbing systems. Electrical panels were exposed, and an electrical outlet showed possible signs of recent fire damage. Site Photo 61 shows the fire damaged electrical outlet.

Site Photo 60: Perimeter security walls and corner guard (Project 18334)

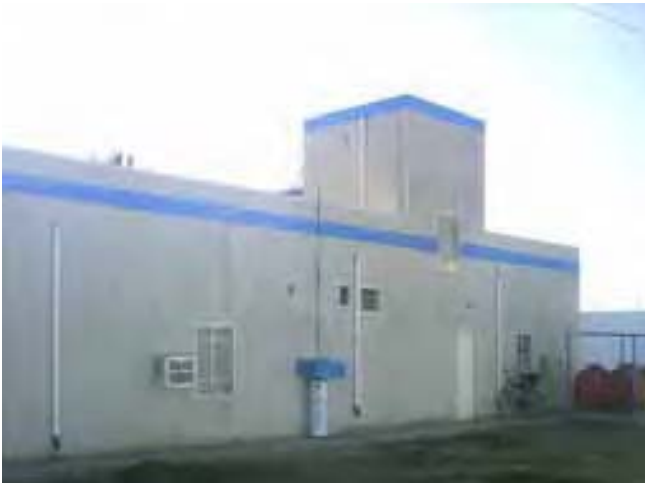
The IRMS database listed the project as 100 percent complete on 30 August - 2005. The project was new construction and included perimeter security walls, entrance gates, guard towers, and a nine-room building. Site Photo 62 shows the exterior of the building. A generator and covered parking area were also located within the perimeter walls. A crack was observed in the perimeter wall, although no other discrepancies were noted. Site Photo 63 shows the crack in the exterior perimeter wall.

**Site Photo 62: Exterior of Police Station building
(Project 19111)**

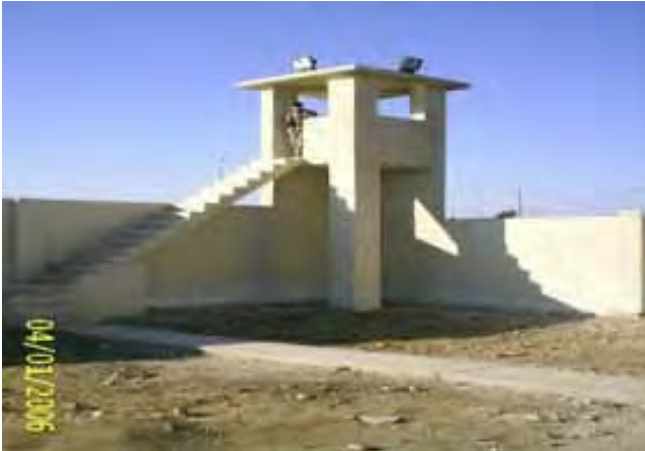
The IRMS database listed the project as 100 percent complete on 2 April 2005. The project included construction of perimeter security walls and corner guard posts, entrance gates, sidewalks, security lighting, and a parking area. Site Photo 70 shows one of the corner guard posts and Site Photo 71 shows a concrete sidewalk. In addition, the contract required renovation of the electrical and pumping systems, roof and ceilings, windows, doors and walls. Construction activities were complete at the time of the visit. Noted discrepancies included rough surfaces and cracks in the concrete parking area and

Site Photo 70: Corner guard post and perimeter walls (Project 19179)

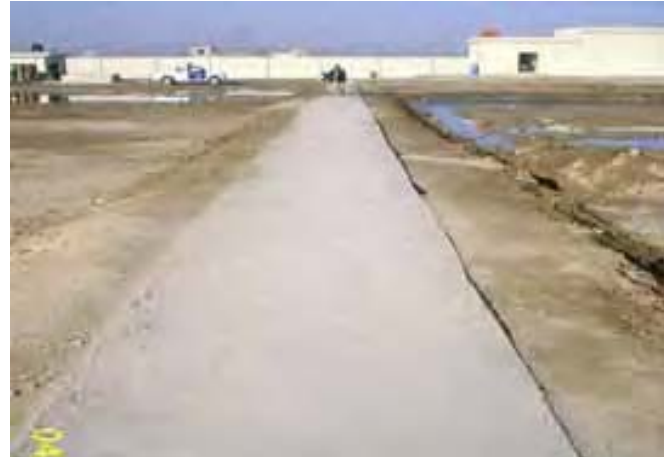
Site Photo 71: Concrete sidewalk (Project 19179)

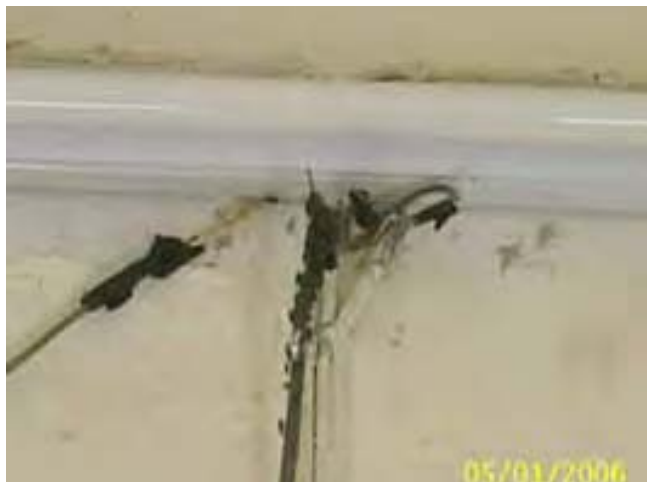
- Electrical systems had exposed wiring, broken fixtures, improper connections, and missing electrical covers throughout the entire police station. Site Photos 74 and 75 show examples of the electrical system deficiencies.

Site Photo 75: Interior electrical light with exposed wiring (Project 19181)

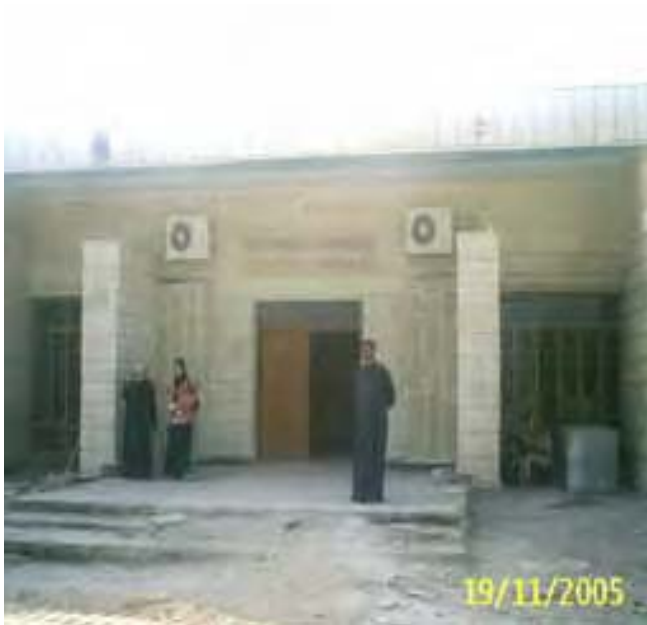
The renovation project was not complete at the time of the survey site visit and work was stopped by the contractor, although the reason was not noted. The Railway Station Manager stated the only defects were the delay and stopping of the work. Additionally, he said the Scope of Work should be increased to include new generators, sunshades, new water tanks, service roads, fencing, outdoors lights and seats for waiting passengers. No discrepancies were noted. Site Photo 84 shows the front entrance of the train station and Site Photo 85 shows the renovated hallway to include suspended ceiling and electrical lighting.

**Site Photo 84: Front entrance of train station
(Project 21263)**

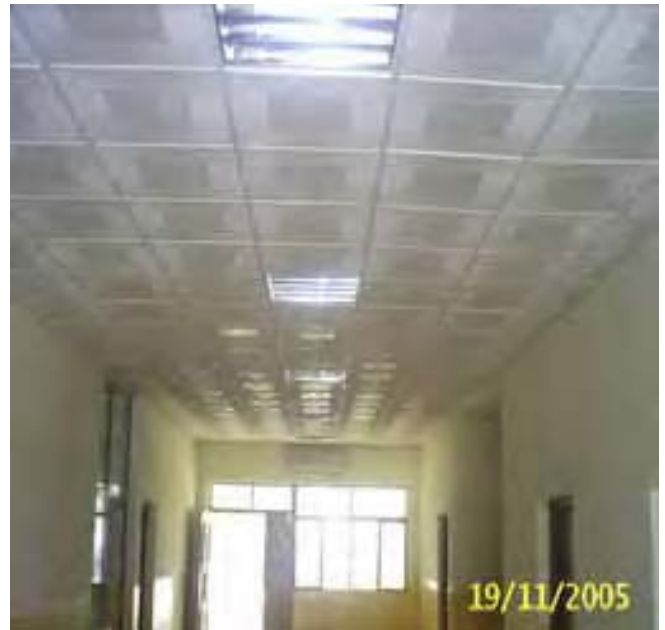
Site Photo 85: Interior hallway (Project 21263)
